CALSPAN ON-SITE AIR BAG DEPLOYMENT INVESTIGATION

CALSPAN CASE NO. CA96-07

**VEHICLE #1 - 1996 FORD CONTOUR GL (AIR BAG EQUIPPED)
VEHICLE #2 - 1983 LINCOLN CONTINENTAL MARK VI**

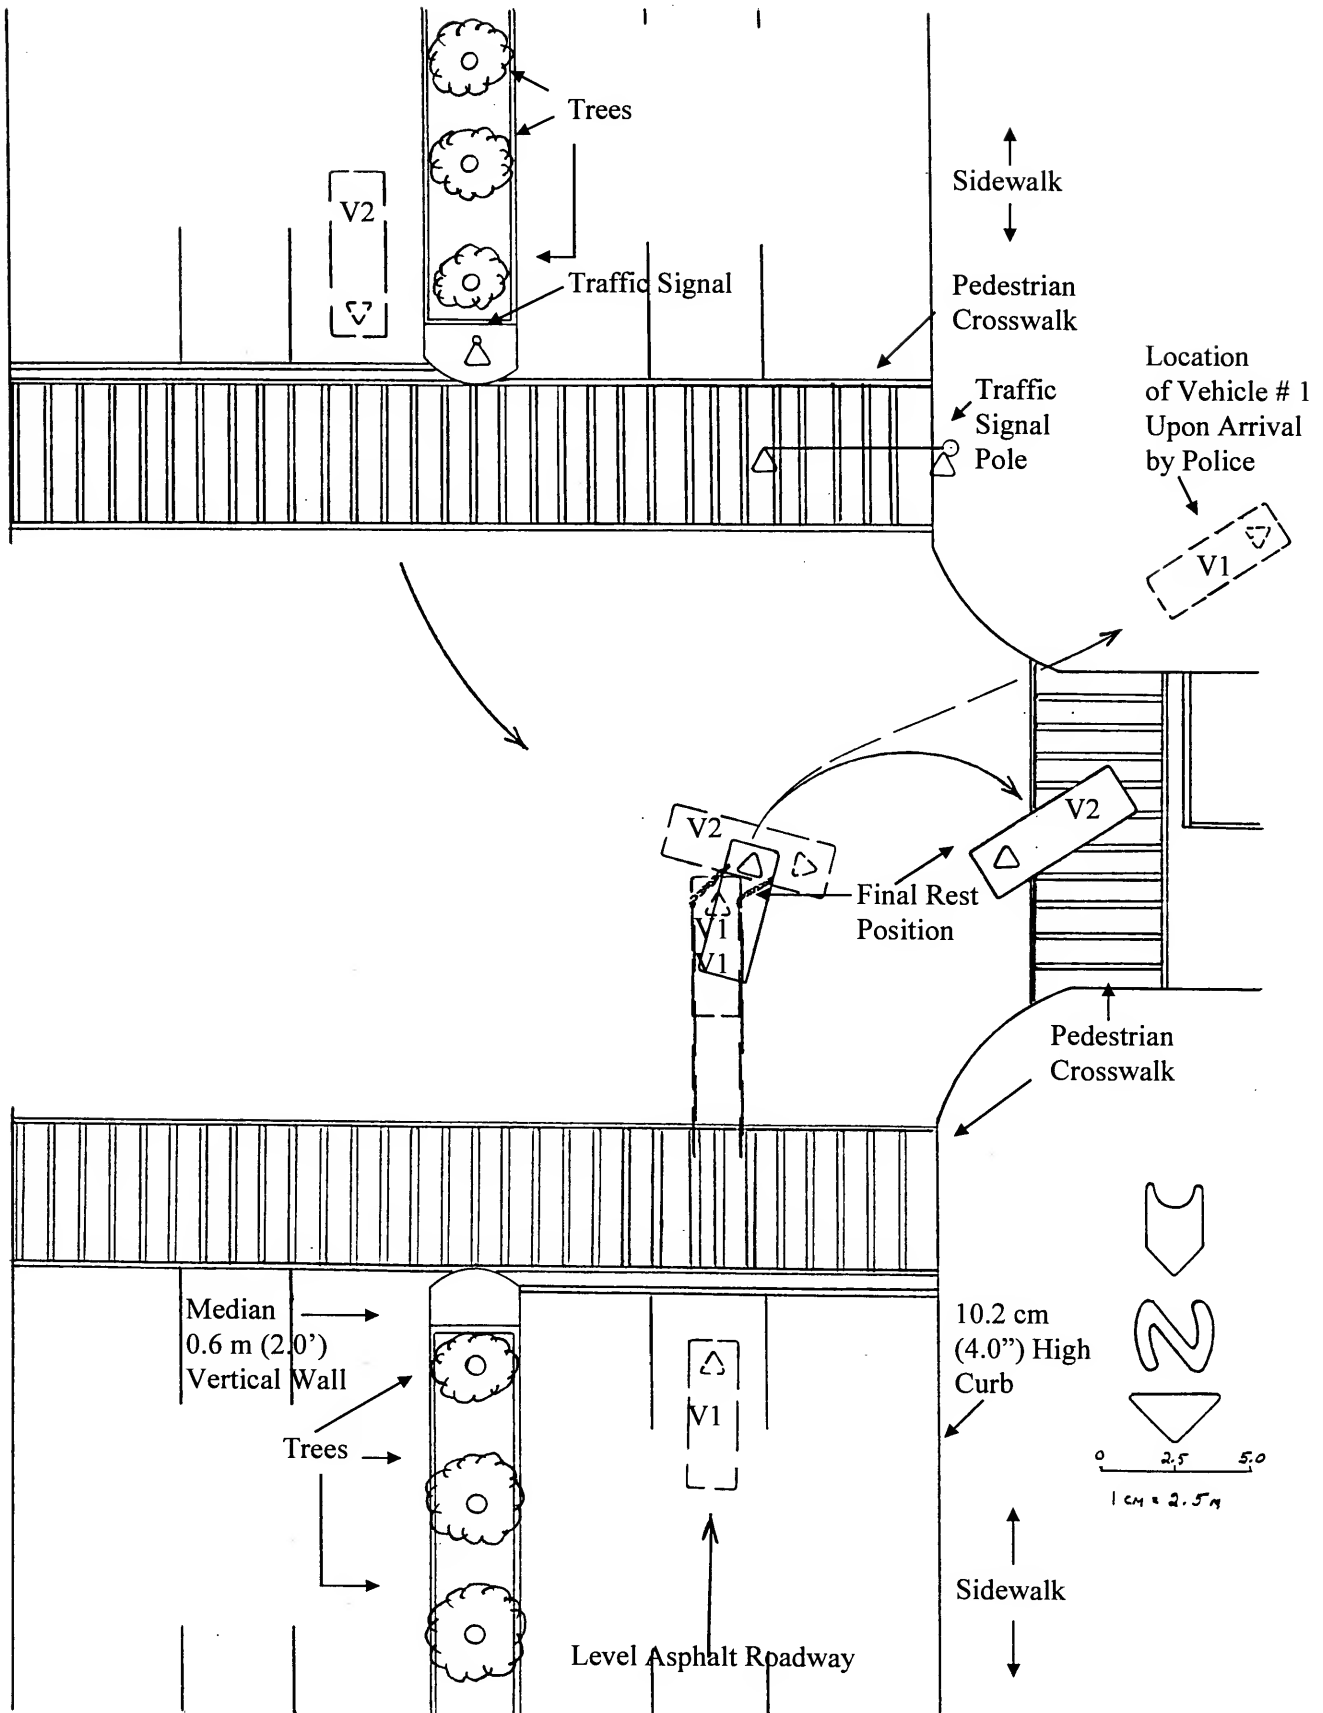
Crash Scene Schematic
Calspan Case No. 96-07

The driver of Vehicle #1 attempted to avoid the crash by applying the brake to a locked wheel condition and skidded 8.5 m (21.6') prior to the point of impact (POI). The entire frontal plane of Vehicle #1 contacted the right side plane of Vehicle #2. Contact on Vehicle #2 began at the leading edge of the right rear door and ended at the right rear fender.

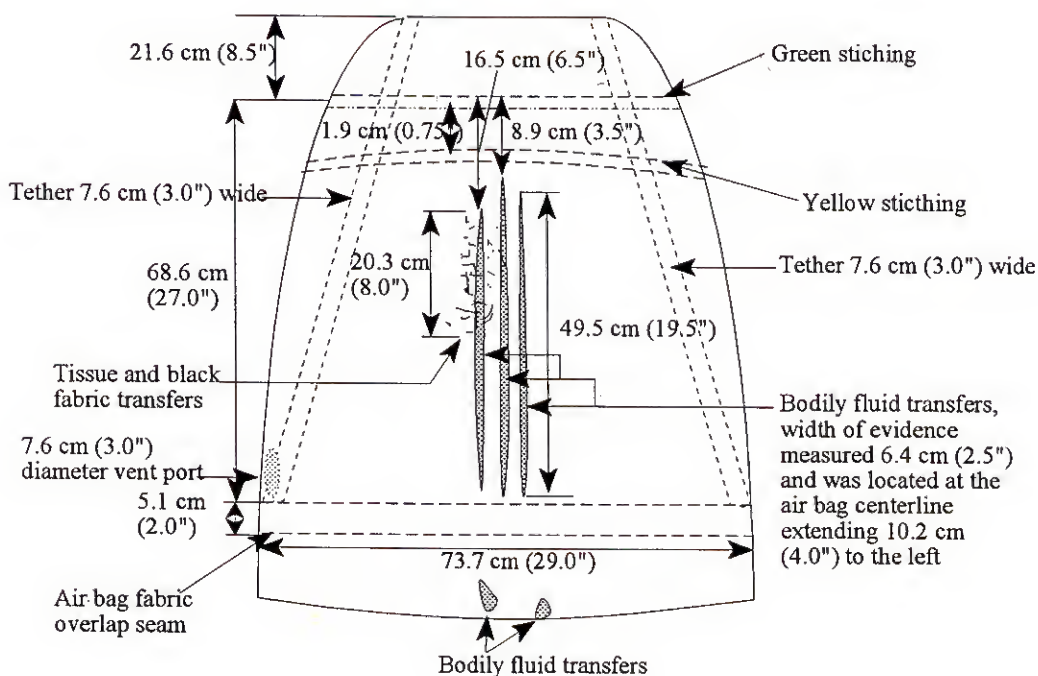
Tethered Passenger Side Air Bag Vehicle #1

The passenger side air bag was constructed with two tethers designed to limit the extrusion of the air bag into the occupant space while providing head and thoracic protection for the occupant. The tethers were located along the left and right side along the front surface of the air bag and attached along a common lateral seam line located 90.2 cm (35.5") from the air bag inflator unit. The tethers measured 7.6 cm (3.0") in width (refer to the following diagram).

The air bag was constructed of a white color nylon fabric with a grid pattern weave. There was one 7.6 cm (3.0") diameter vent port located along the in-board side panel and slightly above the left tether attachment point. The air bag was 73.7 cm (29.0") wide along the common lateral seam for the tethers.

The passenger side air bag exhibited striated bodily fluid transfers located in the center of the air bag which measured 49.5 cm (19.5") vertically. These were the result of contact between the expanding air bag and the right front occupant's neck. Black fabric transfers attributed to contact with the boy's jacket were also observed in the vicinity of these transfers. There were two bodily fluid deposits noted at the bottom of the passenger air bag which were in-line with the striated bodily fluid transfer marks.

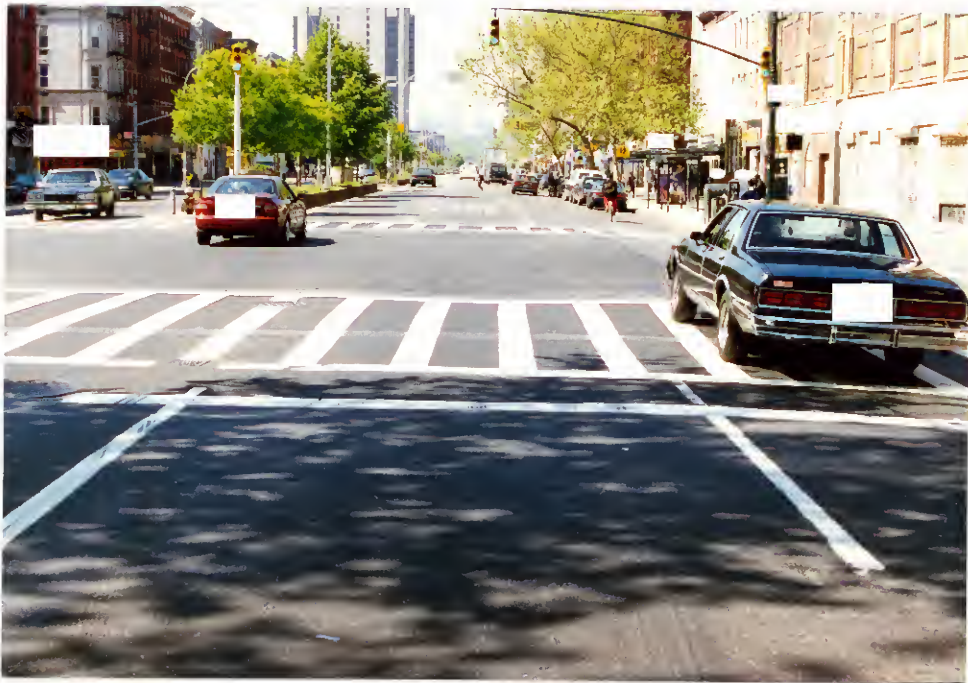
1. View of the 1996 Ford Contour GL (Vehicle #1) travel path southbound 23 m (75') prior to the point of impact (POI).

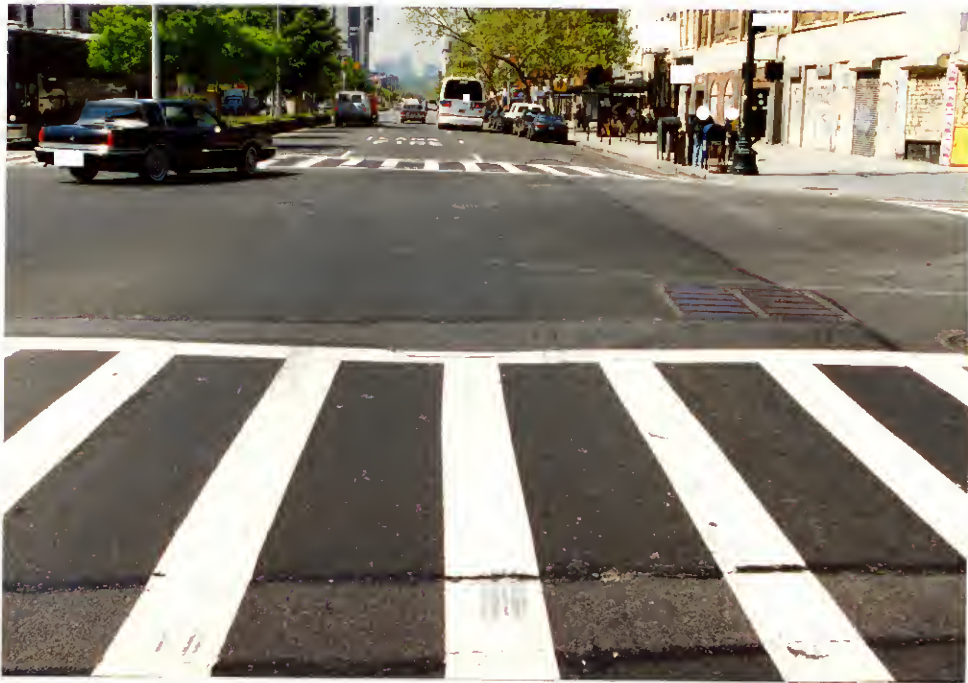
2. View of Vehicle #1's travel path 15 m (50') prior to the (POI).

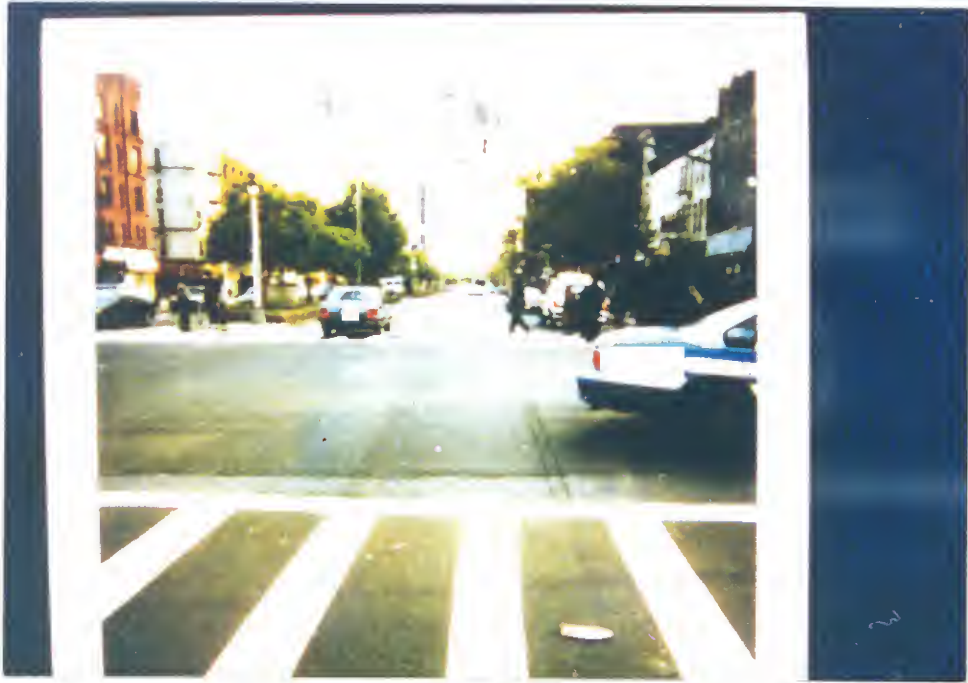
3. On-scene police photograph 15 m (50') prior to POI.

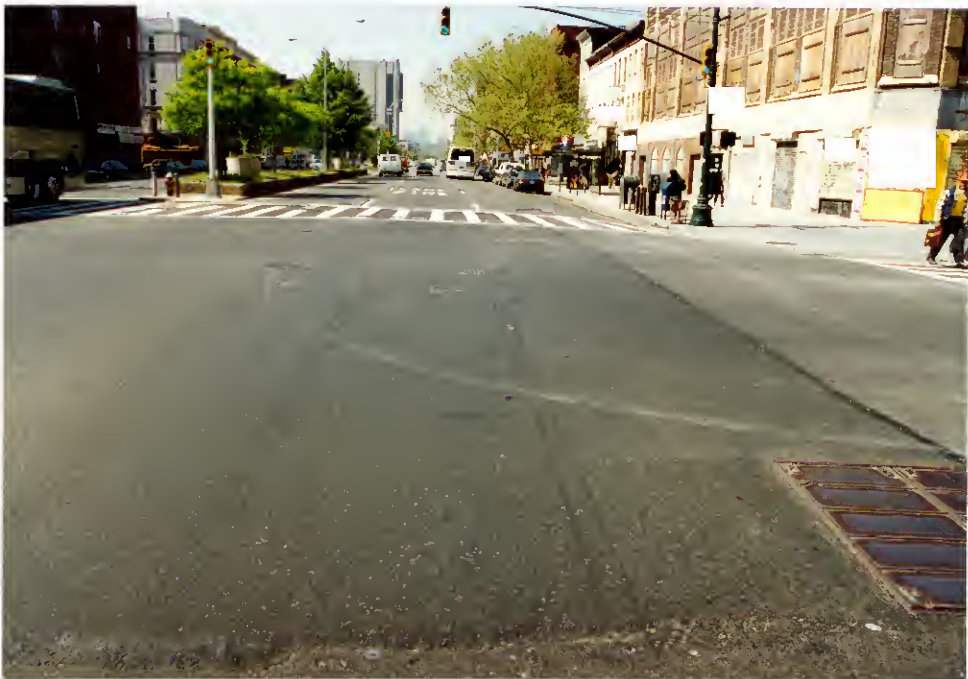
4. View of Vehicle #1's skid marks 7.6 m (25.0') prior to the POI.

path. The driver of Vehicle #1 attempted to avoid the crash by applying the brake to a locked wheel condition and skidded 8.5 m (21.6') prior to the point of impact (POI).

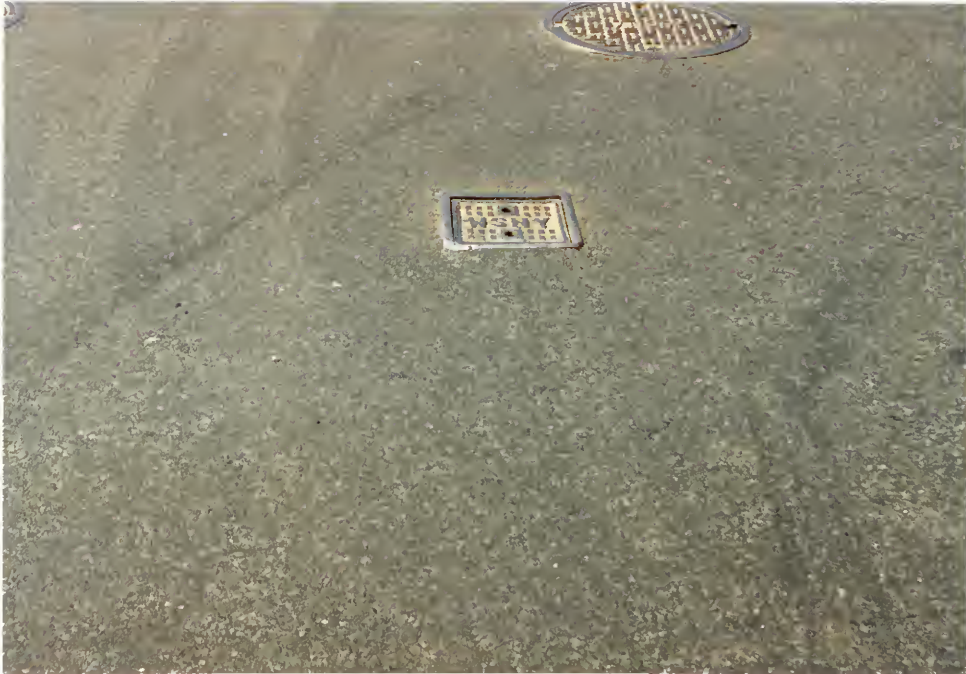
5. Close-up view of the Vehicle #1's tire deflection mark at the POI.

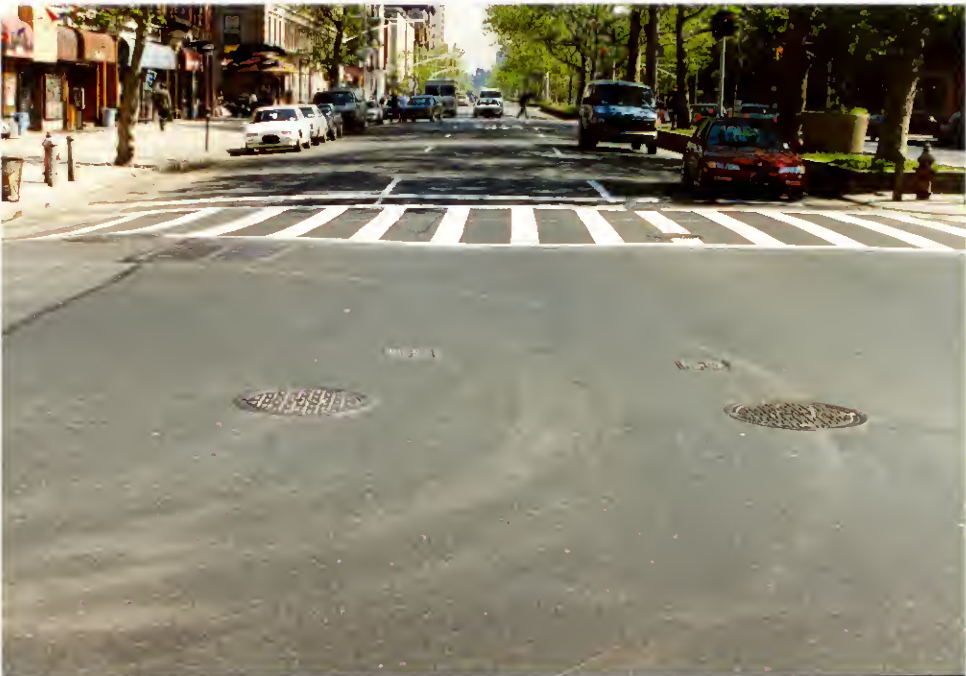
6. Lookback view on Vehicle #1's travel path.

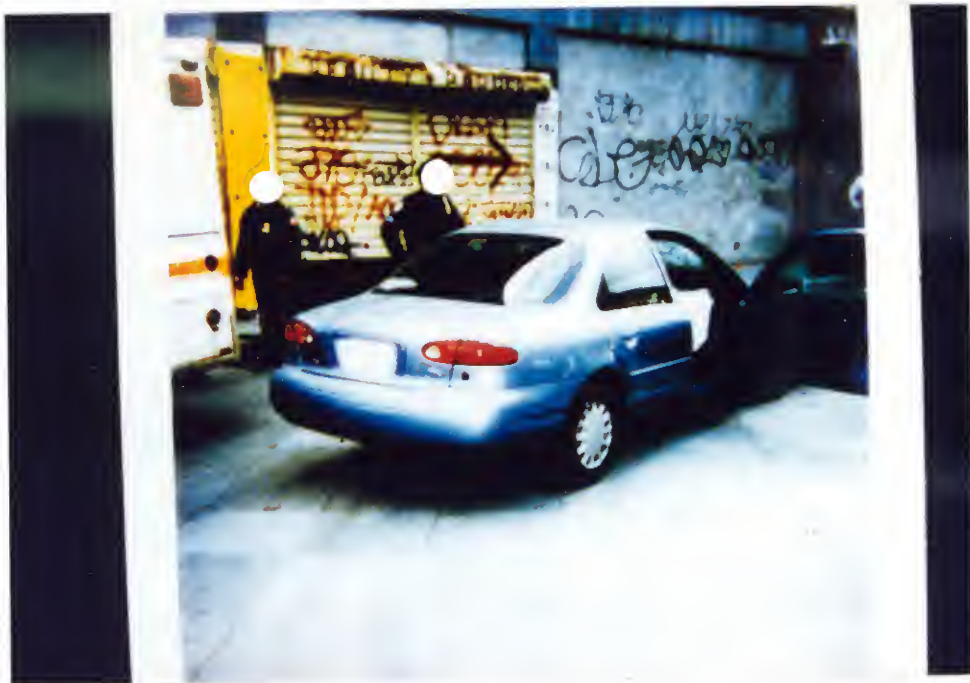
7. On-scene police photograph showing the location of Vehicle #1 on the southwest sidewalk.

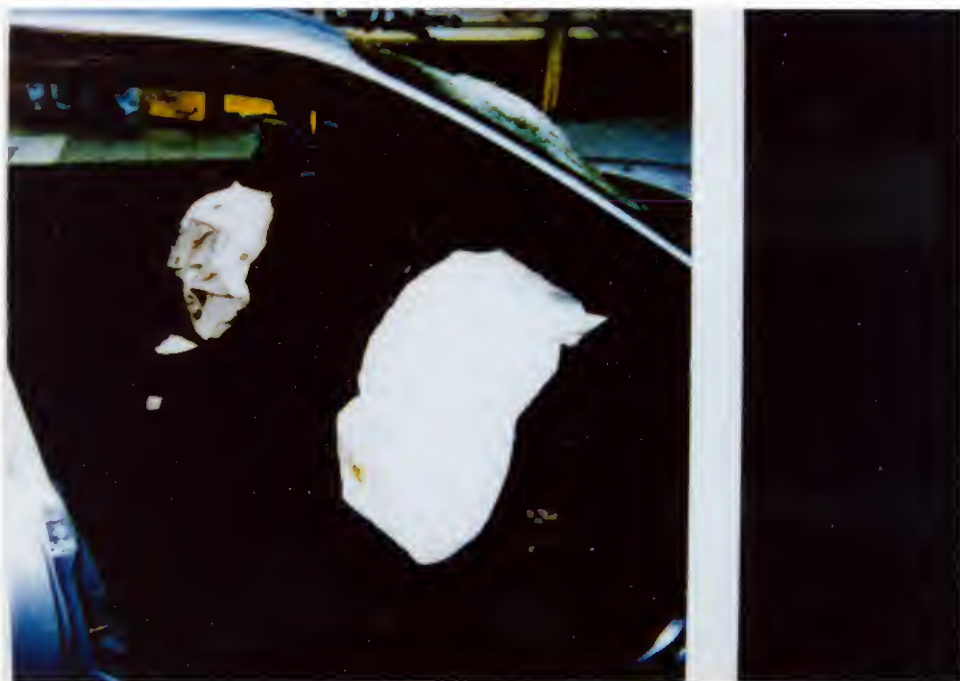
8. On-scene police photograph showing the location of Vehicle #1 on the sidewalk and the deployed passenger side air bag.

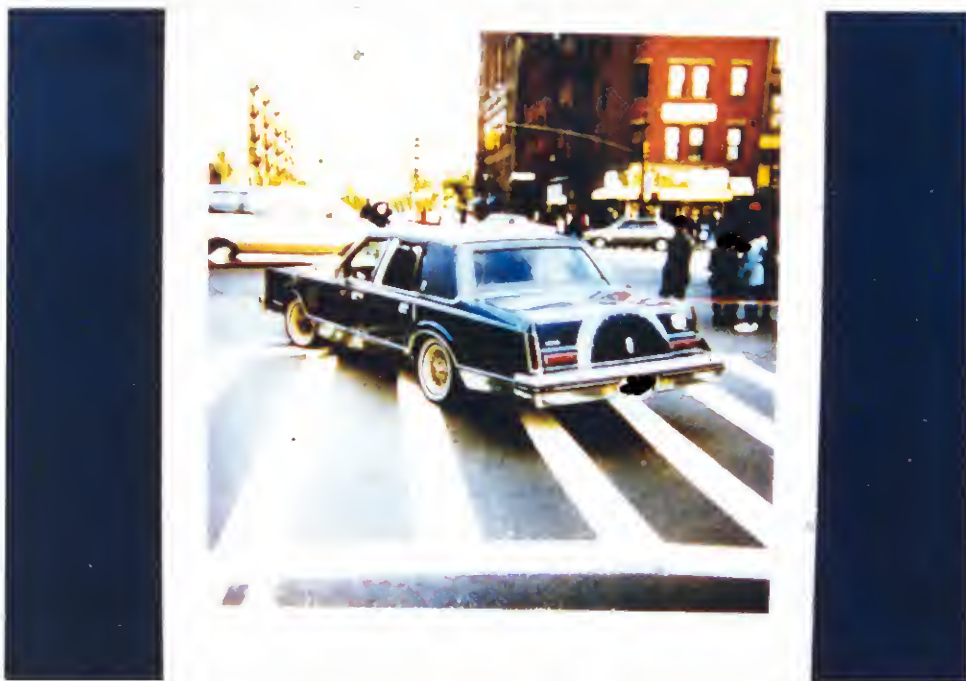
11. Another view of Vehicle #2's FRP.

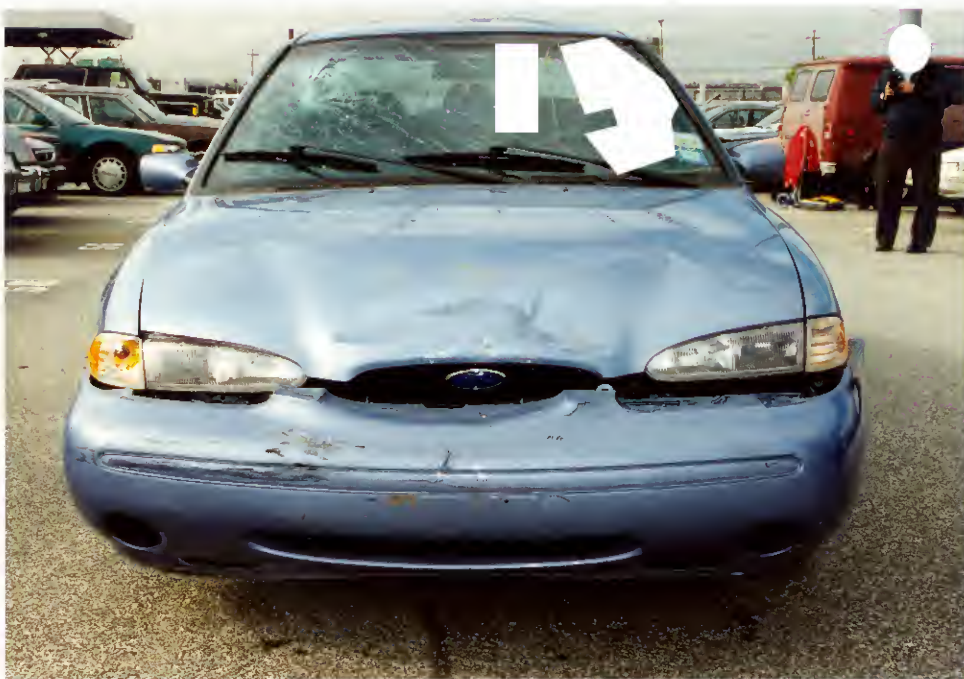
12. Frontal view of the 1996 Ford Contour GL (Vehicle #1) showing the overall contact pattern.

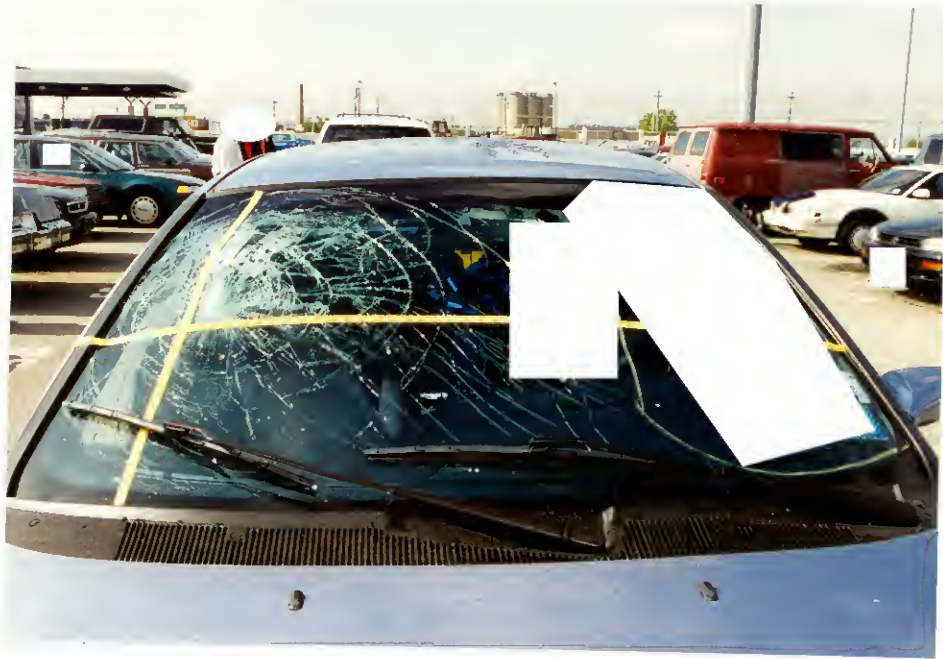
13. View of the windshield showing the location of the right front occupant contact pattern.

The right front occupant moved forward during the braking avoidance maneuver and was in close proximity to the windshield where his head/neck were over the passenger side air bag module cover during the actuation of the SRS deployment sequence. The passenger side air bag module cover opened in an upward rotation where the leading edge contacted his neck and underside of the chin. This action along with the momentum of his body resulted in his forehead/head contacting the windshield. The windshield exhibited a spider web type crack pattern with a 25.4 cm (10.0") long hole through the glazing. Black hair from the boy's head was lodged in the lower and upper ends of the hole. The boy sustained vertically oriented area of superficial abrasions of the forehead at the hairline which were attributed to this contact.

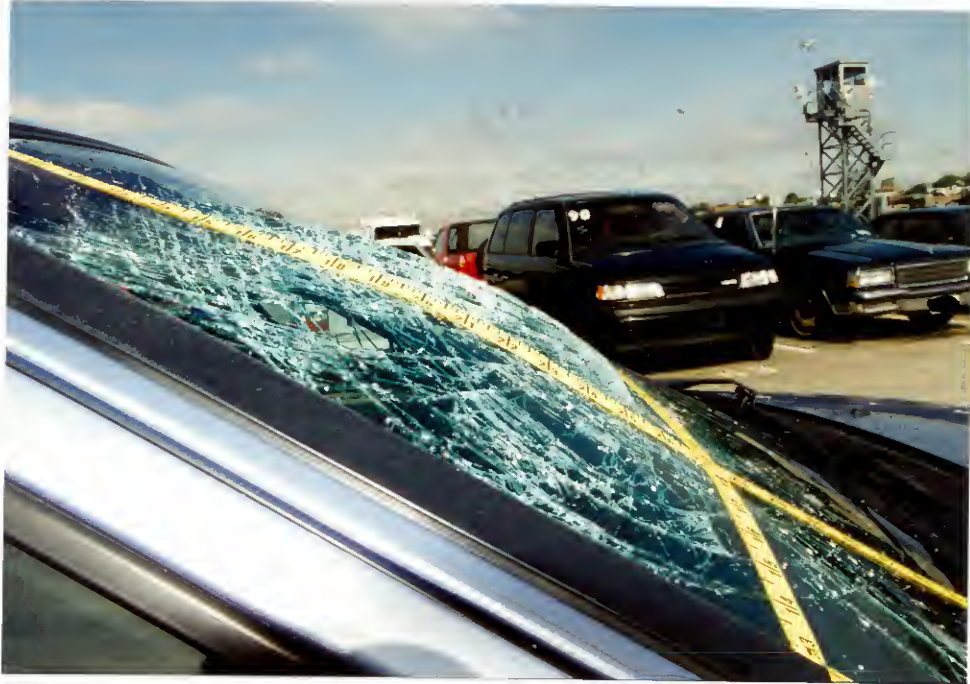
15. Lateral view of the windshield looking toward the left side of the vehicle and illustrating the outward deflection of the glazing.

The windshield glazing sustained a 25.4 cm (10.0") long slit which was located 12.7 cm below the windshield header and 38.1 cm (15.0") right of the vehicle centerline. This was the result of contact by the right front occupant's head during the crash sequence. The windshield also exhibited a wipe mark adjacent to the right upper A-pillar which was attributed to contact by the boy's right hand. A scuff mark attributed to the boy's right arm was noted on the in-board surface of the upper right A-pillar. Black hair fibers noted in the fabric covering over the windshield header located directly above the slit in the windshield were attributed to contact by the boy's head during the crash. There were scuff marks on the surface of the glove compartment door which were attributed to contact by the right front occupant's knees and lower legs.

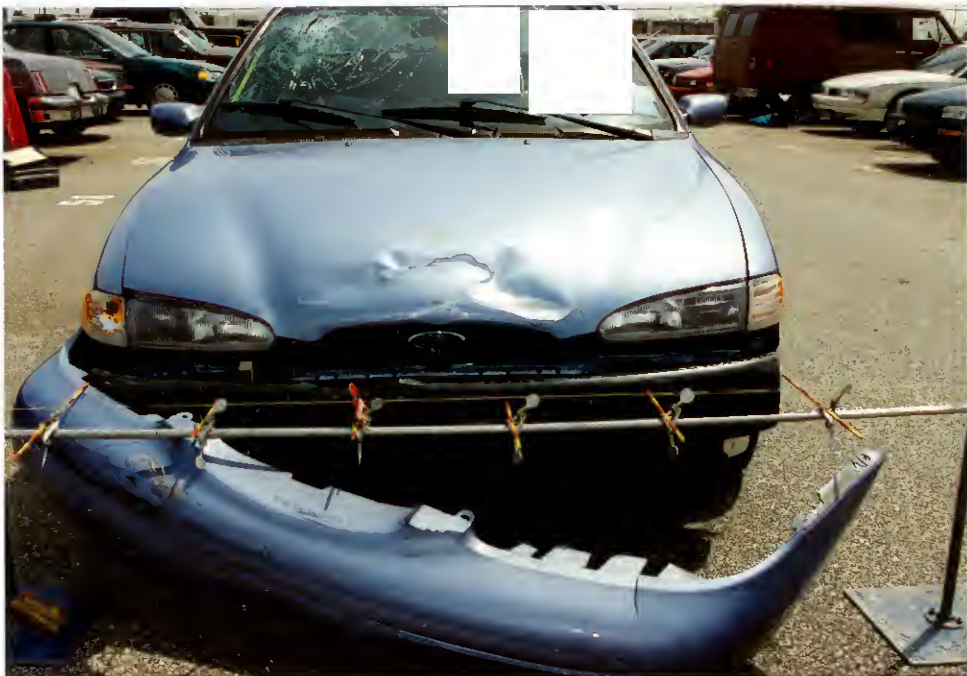
16. Frontal view of Vehicle #1 with the bumper fascia removed and calibrated measuring rods placed along the bumper reinforcement bar.

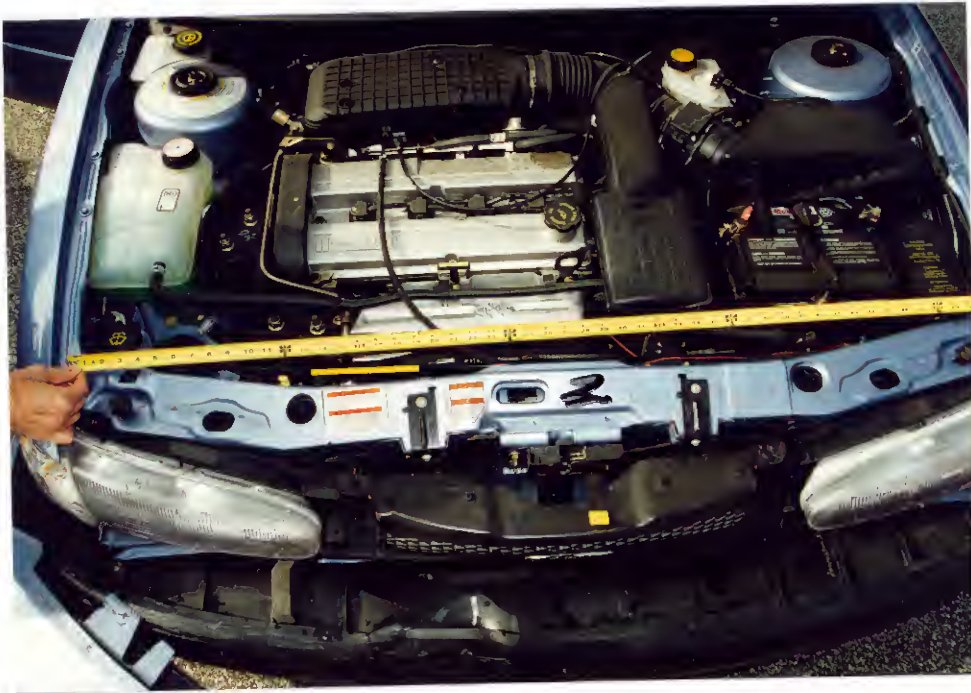
19. View of the engine compartment and showing the location of the two air bag system crash sensors.

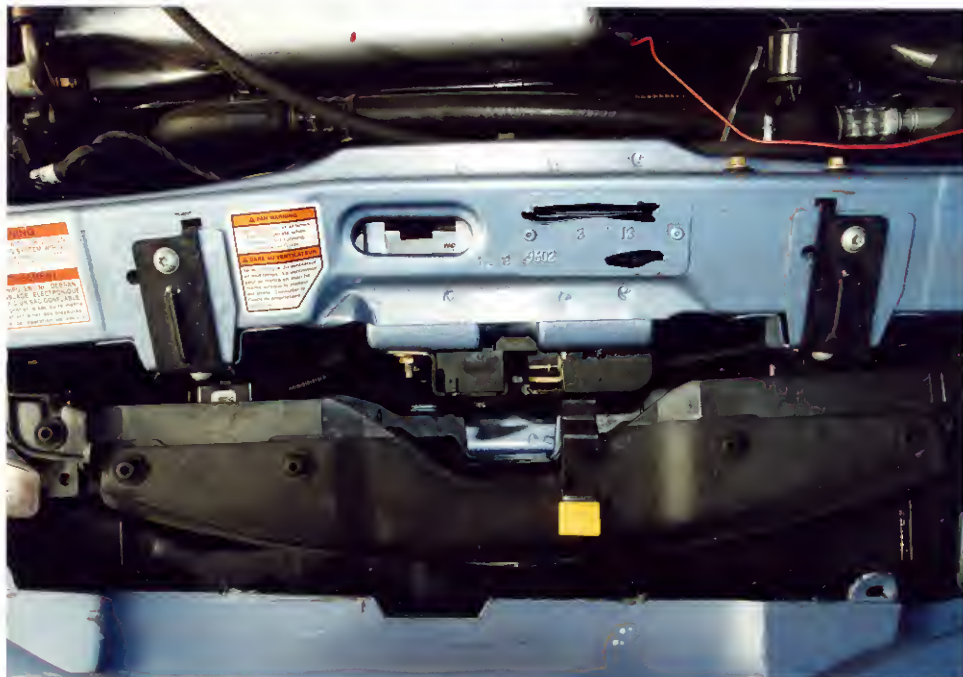
20. Close-up view of the air bag system crash sensors.

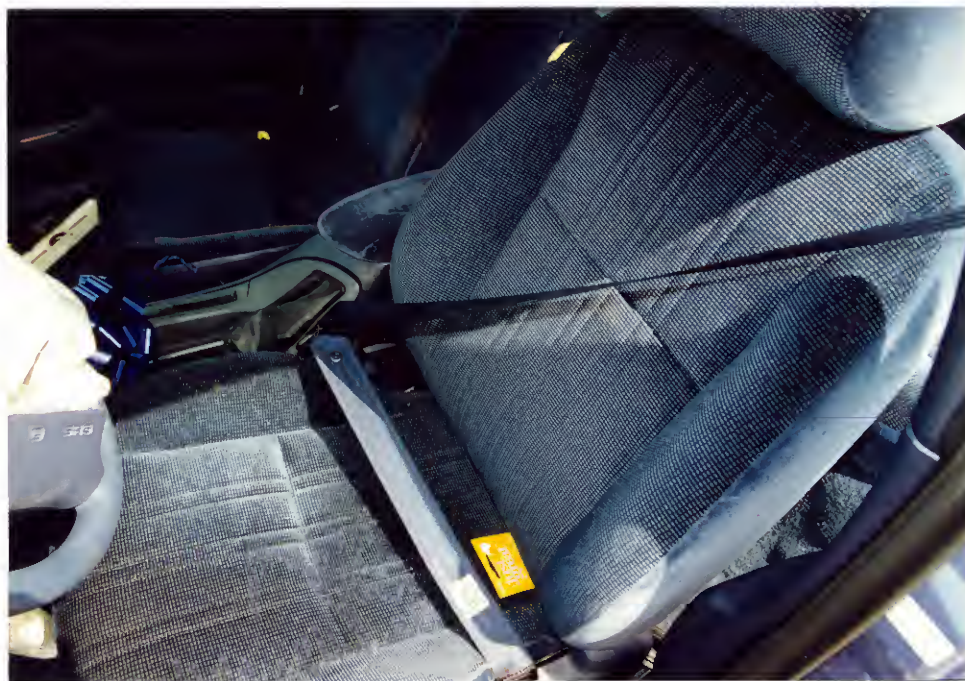
26. View of the driver side lap and shoulder belt latched into position showing no visible signs of at crash usage.

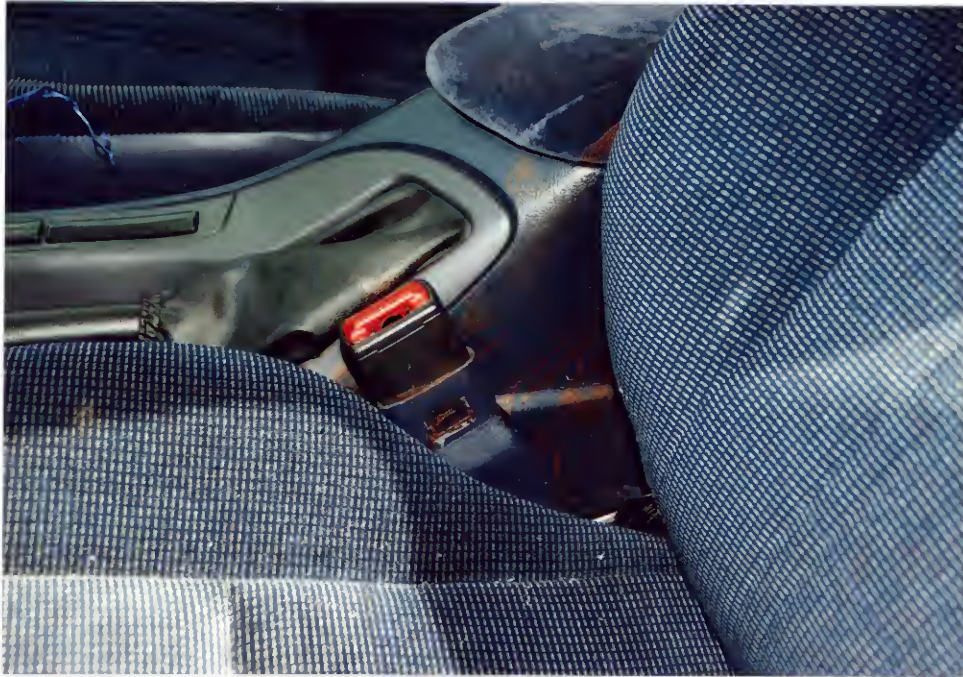
27. View of the driver side buckle illustrating the presence of bodily fluid transfers on the underside of the buckle.

At the time of the crash, the driver's seat was adjusted in a forward position between middle track position and full forward. The driver was not wearing the available three-point manual lap and shoulder belt. Just prior to the crash, the driver applied the brakes in a panic braking maneuver.

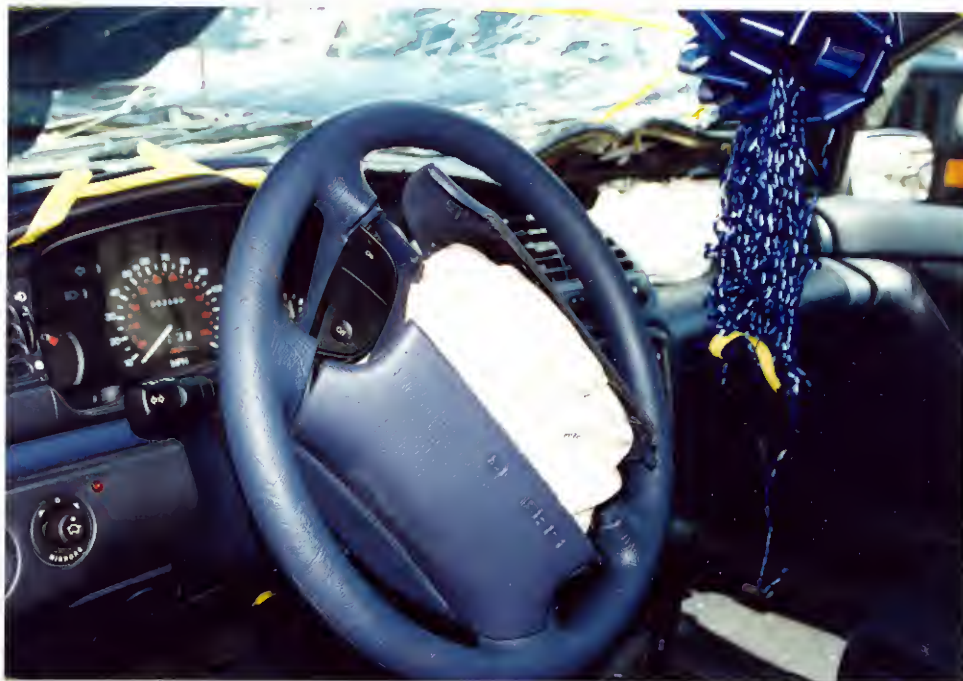
28. Close-up view of the driver's side air bag module cover with the air bag placed back into the air bag module.

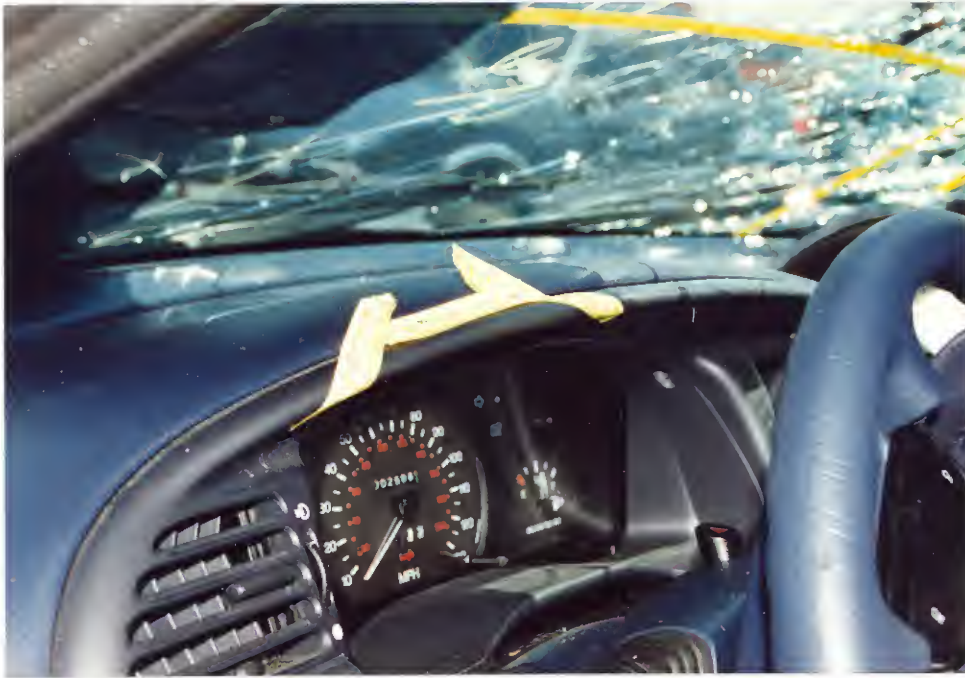
29. Close-up view of the contact evidence on the instrument eyebrow panel.

In response to this braking and impact forces, Driver #1 moved forward and came in contact with the deploying driver side air bag. A red cosmetic transfer (i.e., lipstick) was noted on the driver side air bag which was located near the center. Her left arm was propelled forward by the driver side air bag and contacted the eyebrow of the left instrument panel. A 12.7 cm (5.0") scuff mark was noted along the leading edge of the eyebrow which was located 35.6 cm (14.0") left of the vehicle centerline.

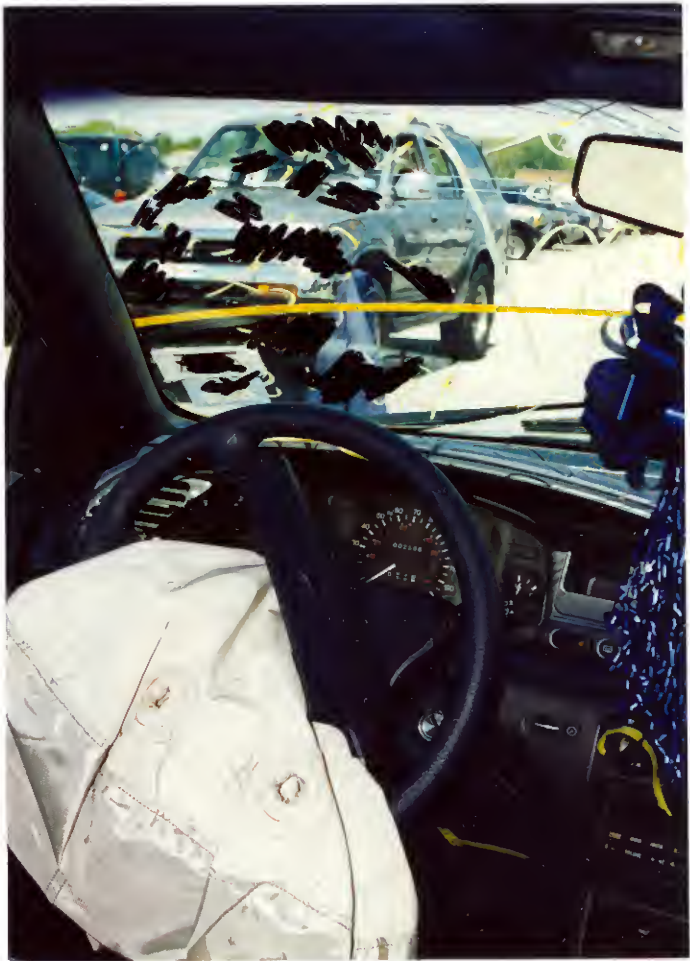
32. View of the driver side air bag.

A red cosmetic transfer (i.e., lipstick) was noted on the driver side air bag. It was located near the center and was the result of contact by the driver's facial area during the air bag deployment sequence.

A red cosmetic transfer (i.e., lipstick) was noted on the driver side air bag. It was located 5.1 cm (2.0") right of center and 5.1 cm (2.0") below the center. This transfer was the result of contact by the driver's facial area during the air bag deployment sequence.

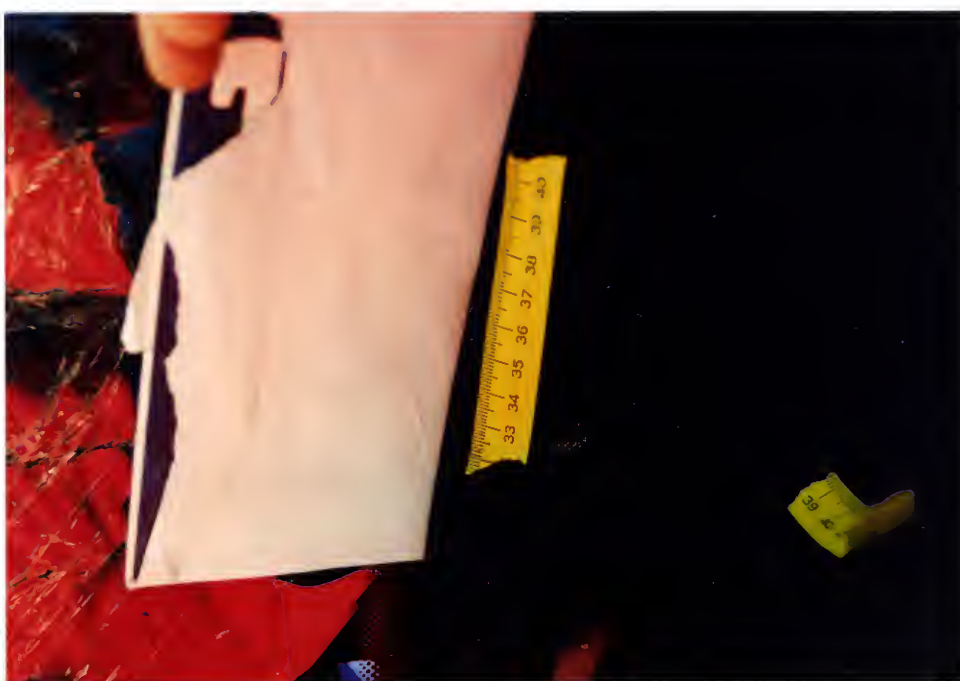
36. Hair fibers associated with contact by the right front occupant are visible at the leading edge of the windshield header.

The boy's head then moved upward and rearward striking the windshield header as noted by strands of hair embedded in the fabric overlaying the windshield. This contact was associated with the subscalpular contusion of the right occipito-parietal area. His torso then moved rearward and he came to rest between the front bucket seats with his head on floor behind the center console and his buttocks on the center console surface with his chest facing upward.

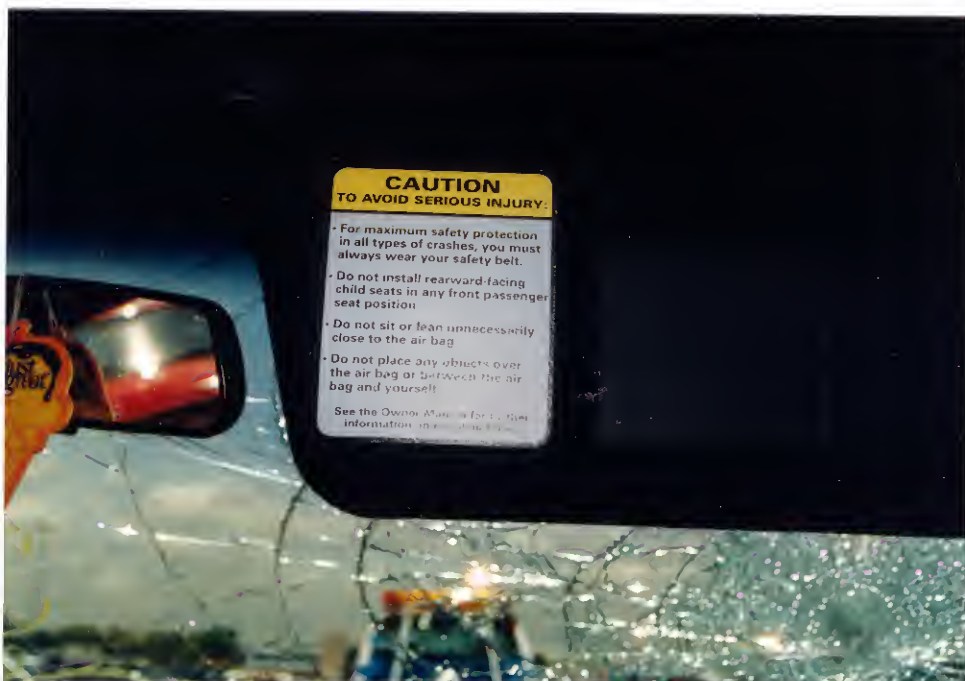
37., 38, Air bag warning labels on the up side of the left and right sunvisors (respectively).

Restraint warning labels were present on both surfaces of both sunvisors advising the driver and right front occupant to wear the safety belts and to sit back away from the air bag. The labels visible on the sunvisors in the up position were printed with black lettering on a white background and stated "Air Bag, See Other Side". The labels on the flip side were also printed white on black with a yellow cautionary background at the top which read:

- For maximum safety protection in all types of crashes, you must always wear your safety belts.
- Do not install rearward-facing child seats in any front passenger seat position.
- Do not sit or lean unnecessarily close to the air bag.
- Do not place any objects over the air bag or between the air bag and yourself.

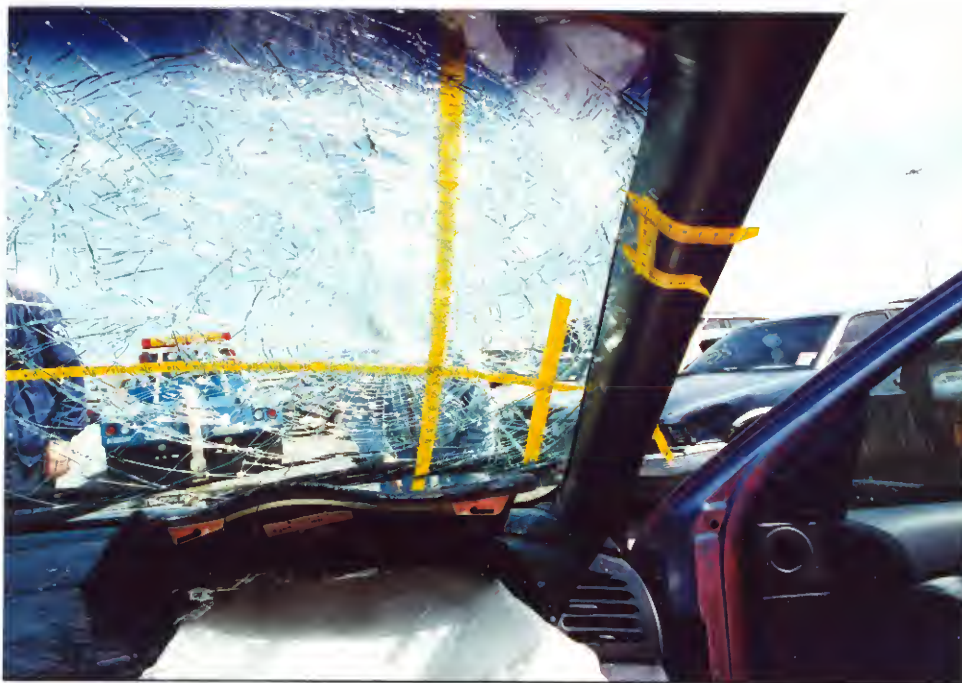
39., 40. Views of contact evidence on the windshield by the right front occupant's head.

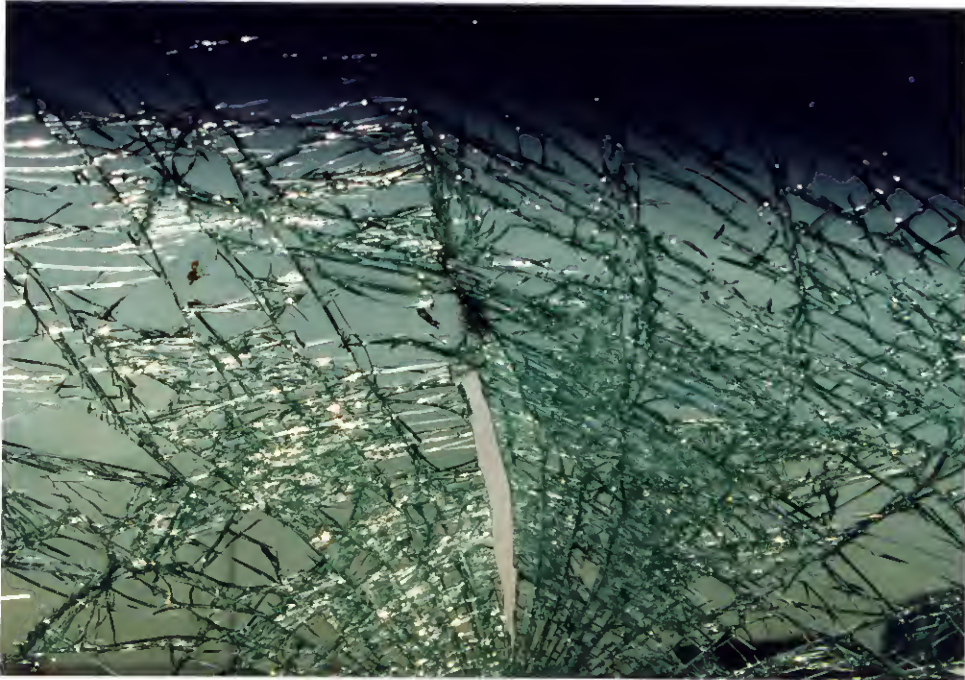
41., 42 Close-up views of hair fibers in the windshield glazing resulting from contact by the right front occupant's head.

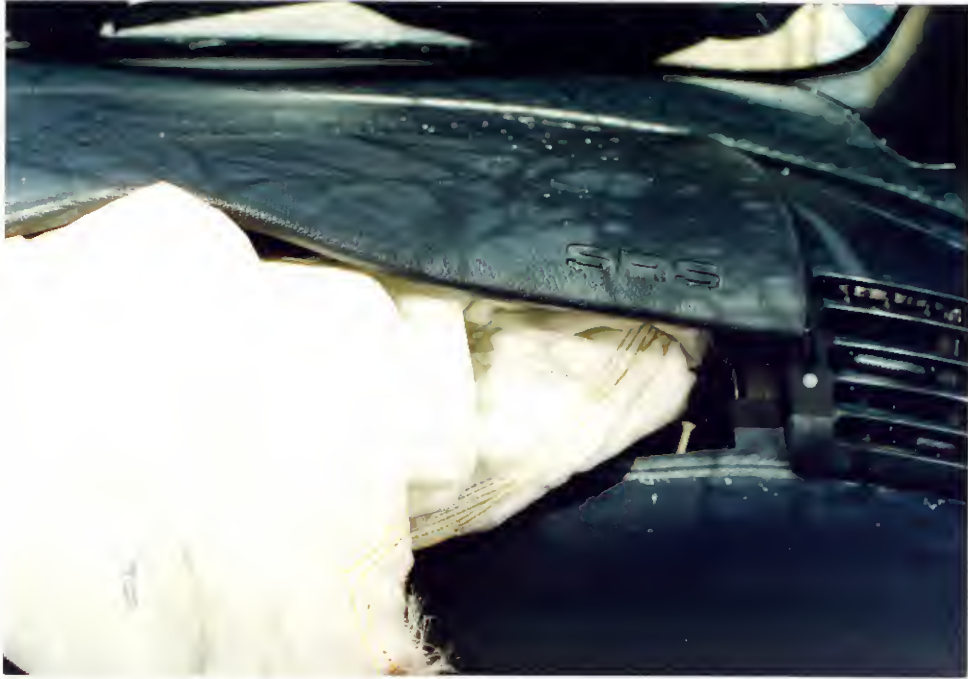
45. View of the passenger side air bag module cover.

Damage to the interior was associated with occupant contacts and the air bag deployment event. The passenger side air bag module cover exhibited a serpentine profile along the leading edge which resulted from contact with the right front occupant's neck during deployment. The vertical rise in the cover along this edge measured 1.9 cm (0.75") and was located 11.4 cm from the left corner of the cover.

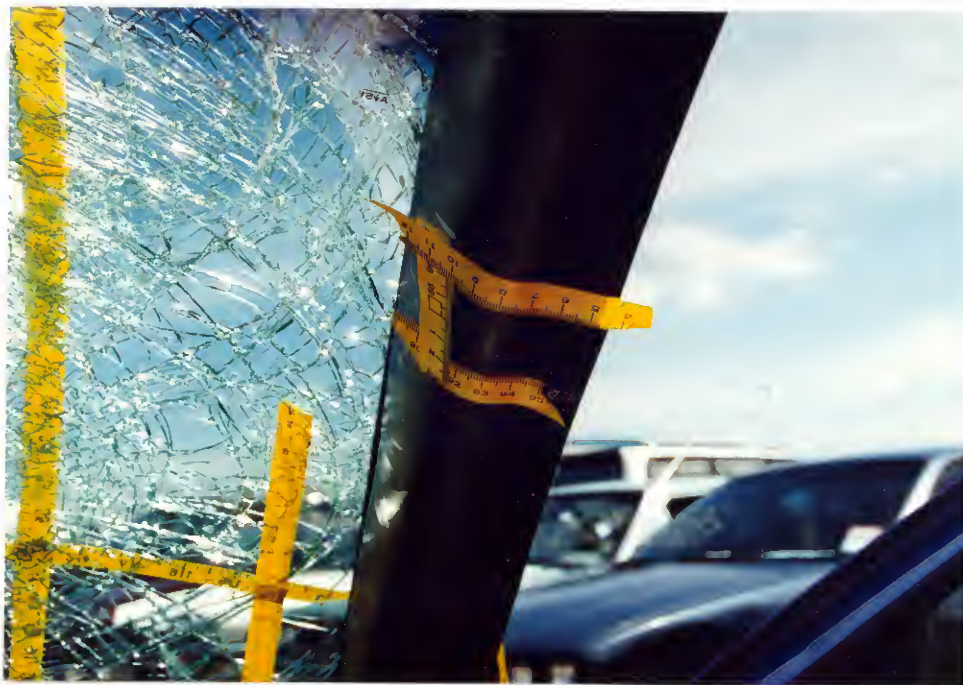
43. View of contact evidence on the upper right A-pillar.
